SUBJECT: FIELD INVESTIGATION – HEXAZINONE WELL SURVEY

REPORT OF FIELD INVESTIGATION
OF PCPA DETECTION AREA

Attachment 3 – Site Inspection Photographs and Maps

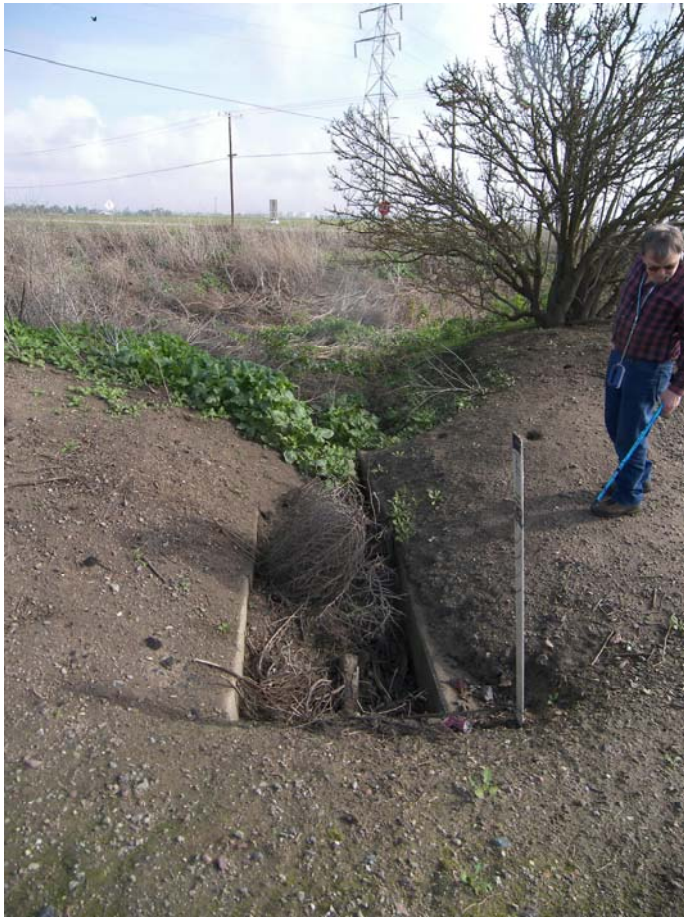
Filled culvert/pipe output connecting 2 runoff ponds in NE corner of section 25. Pond was vegetation filled and smaller than the manicured pond on the other side of the road. Location 3904 is the white house in the picture below.

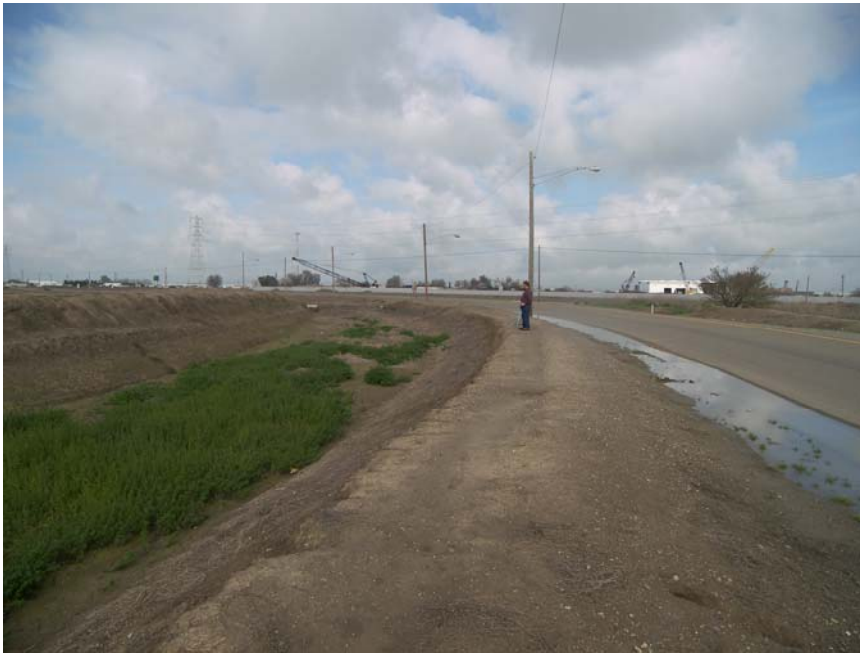
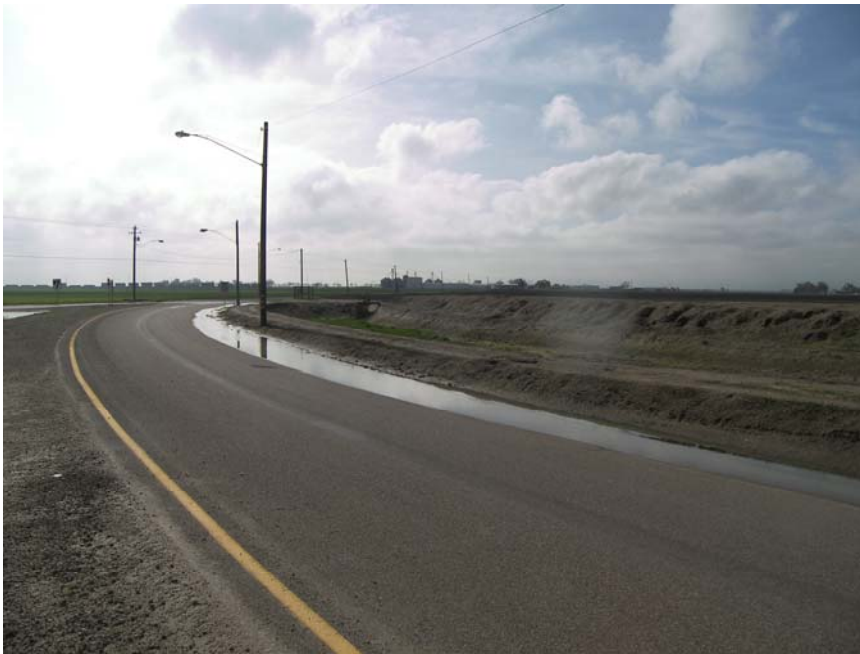
Picture above and below shows the larger of 2 connected ponds in the NE corner of section 25. Connection runs under the road. Ponds collect water from the large field to the SW.

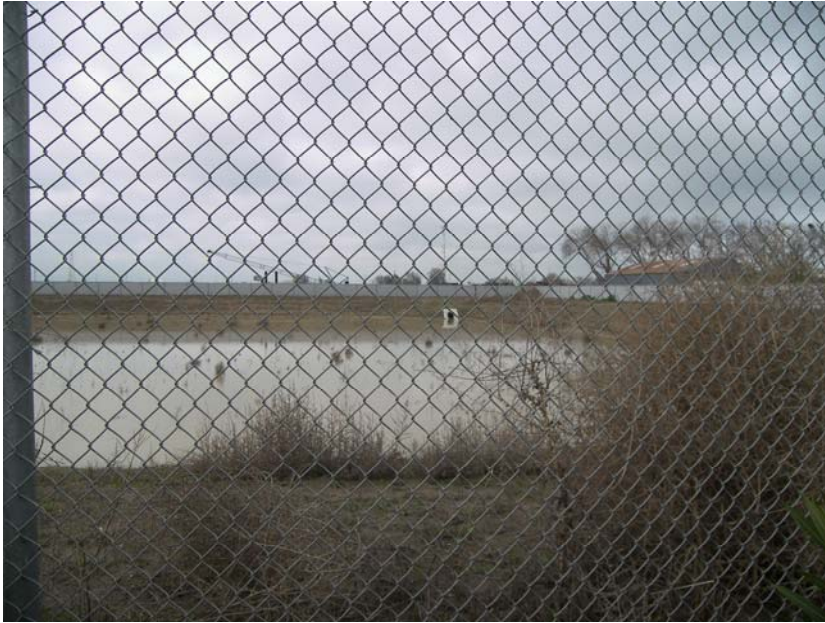
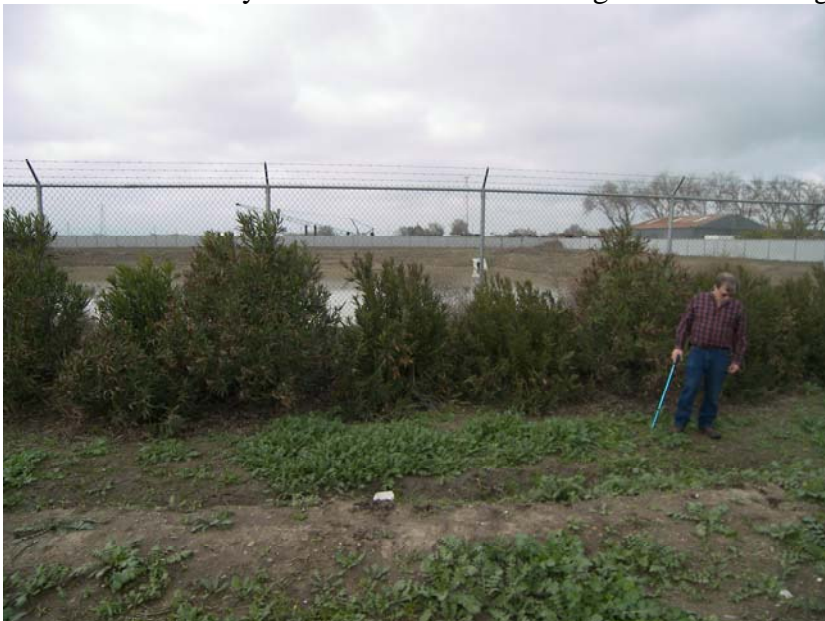
Two pictures looking west of a large runoff pond in the SE corner of section 24. This pond drains an industrial/ vehicle yard area to the north. No agricultural drainage was noted

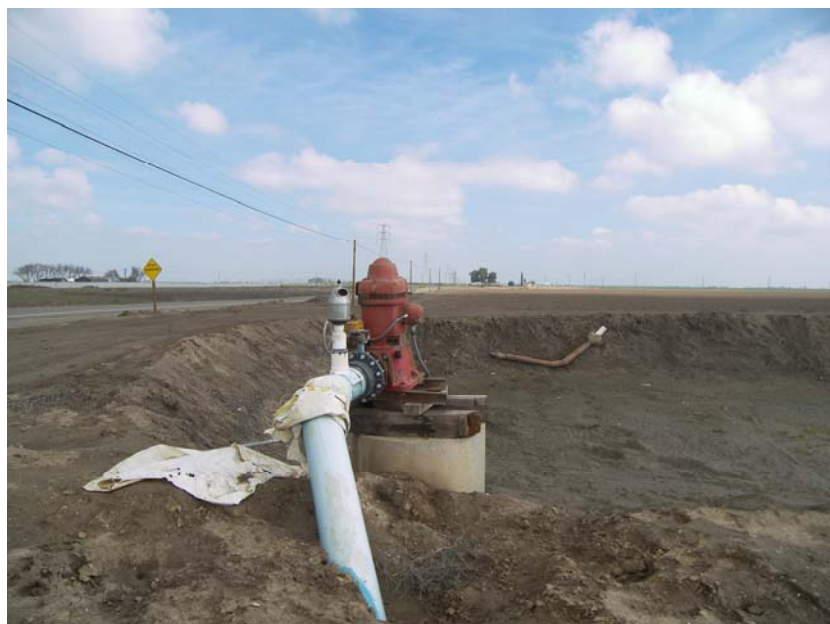
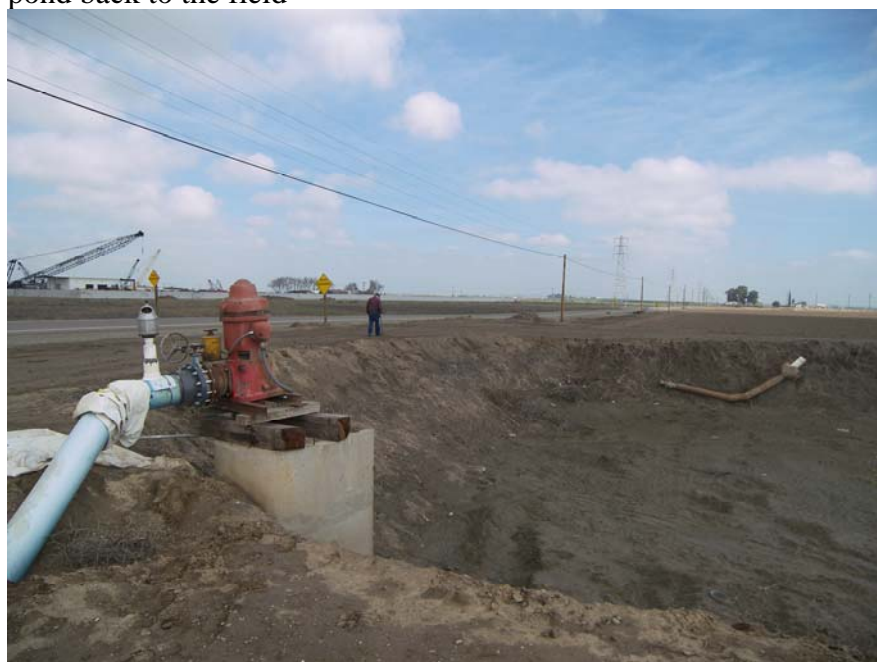
Large runoff pond in the north central area of Section 25. Pump appears to be used to recycle water from the pond back to the field
